# Single-Phase Reclosers on Rural Distribution Lines Help Utility Improve Reliability

**S&C Featured Solution:** Advanced single-phase cutout-mounted recloser

**Location:** Minas Gerais, Brazil

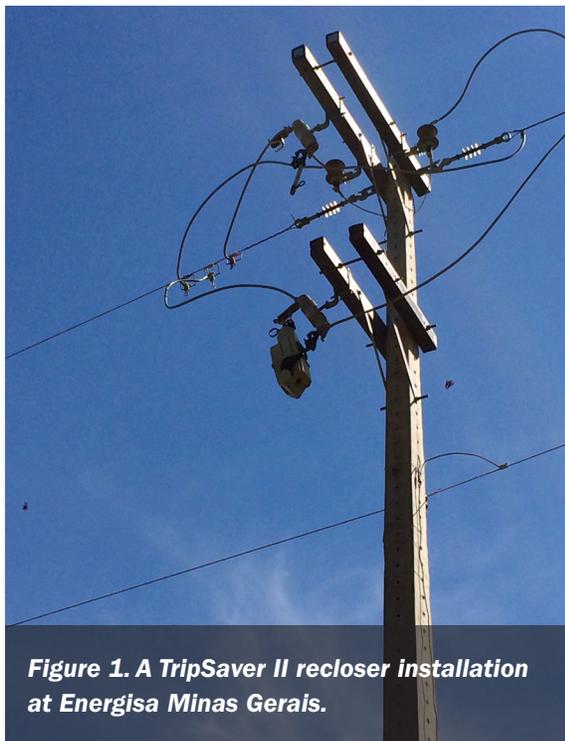
**Figure 1.** A TripSaver II recloser installation at Energisa Minas Gerais.

After analyzing various single-phase reclosers, Energisa Minas Gerais decided on the S&C TripSaver® II Cutout-Mounted Recloser. It liked that its unique design enabled mounting in a standard S&C Type XS fuse cutout, conducted four operations before dropping open, and that it had a high interrupting rating, which allows TripSaver II units to be applied in more locations. Moreover, with more than 200 different Time-Current Characteristic curves to choose from, it provided greater coordination flexibility.

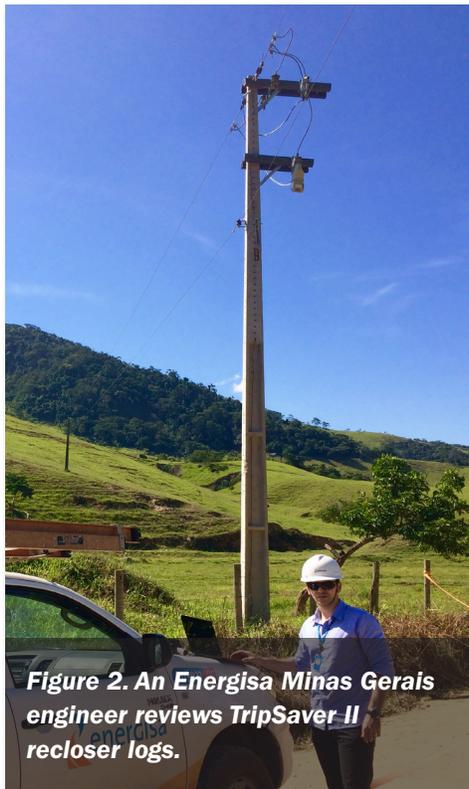
**Figure 2. An Energisa Minas Gerais engineer reviews TripSaver II recloser logs.**

Energisa Minas Gerais had detailed historical feeder-performance information for all 10 installation locations. After one full year in service, the utility found when comparing the historic data with the data logs from the TripSaver II units, the overall improvement in all measured performance metrics was over 91%. See Table 1. The significant reduction in truck rolls to replace fuse links when temporary faults occurred and the associated savings resulted in a viable short-term payback.
